MONUMENT RECORD
State of Indiana - County of Monroe

Corner ID: Polk E-13

LAND CORNER RECORD

POLK E13

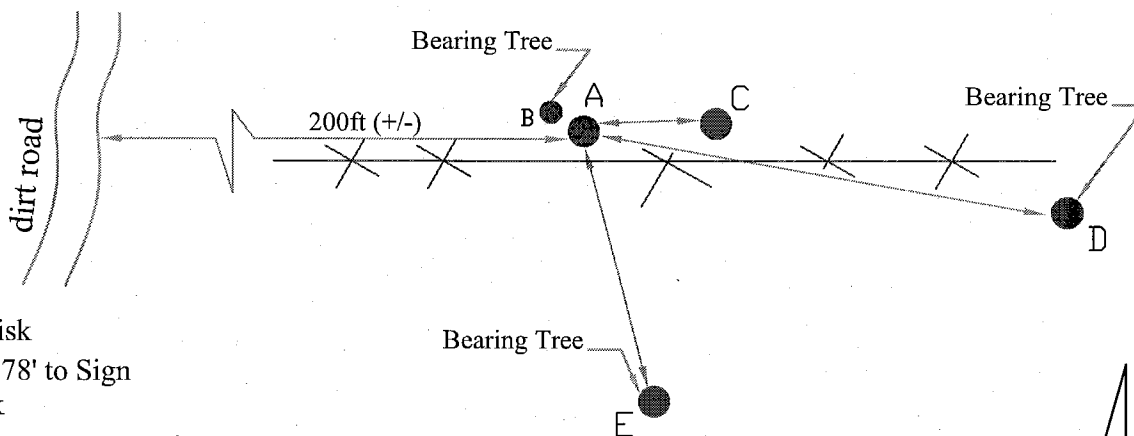
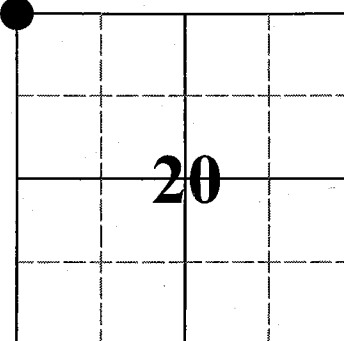
RECOVERY TIE DRAWING
Field Book 39 Page No. 11

Monument Description & Remarks: 3" Brass Disk 6" above ground. Survey Sign 5ft above ground at pt. C

- A - 3" Brass Disk
- B - N 40° W 0.78' to Sign
in 29" Red Oak
- C - S 85° E 2.85' to Survey Sign
in 10" Sugar Maple
- D - S 75° E 18.13' to Sign
in 17" White Oak
- E - S 02° W 7.19' to Sign
in 9" White Oak
